# Bristol - Isolocork on Lime Render

## Spray Cork Project Case Study

External renovation of an existing lime-rendered residential property in Bristol. Isolocork spray cork was applied as the external finish, retaining a textured appearance while providing a continuous cork-based coating across the treated elevations.

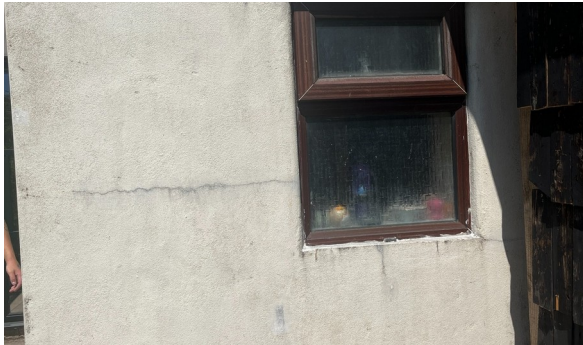
#### Existing condition

Weathered lime-rendered wall before preparation, with visible staining and cracking.

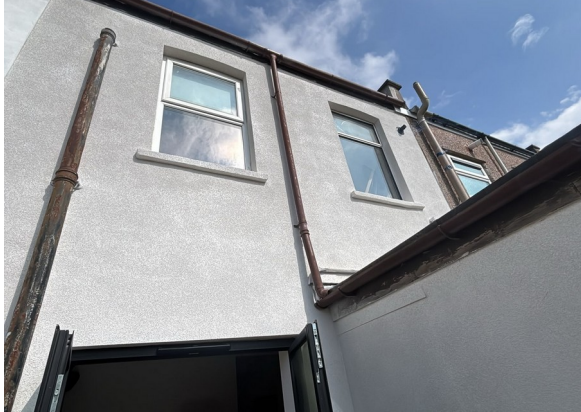
## Finished surface

Close view of the completed Isolocork finish around the upper rear elevation.

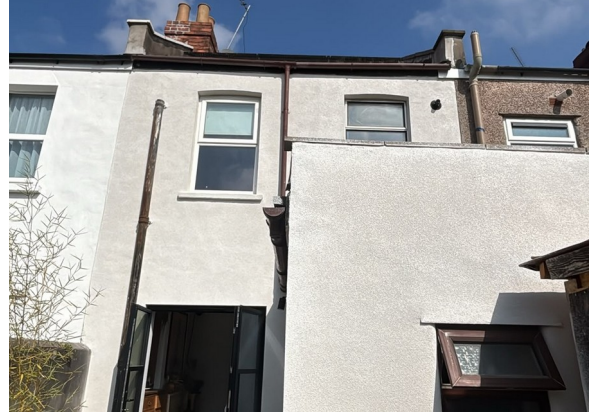
## Completed elevation

Overall view of the completed rear elevation following application.
