# Ilfracombe - Isolocork on Lime Render

## Spray Cork Project Case Study

External renovation of an existing lime-rendered residential property in Ilfracombe. The existing finish was prepared and protected before Isolocork spray cork was applied as a continuous textured external finish.

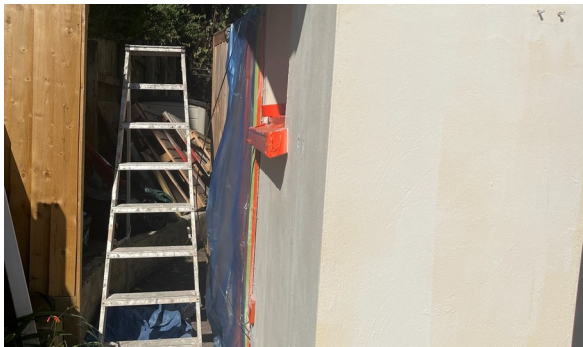
#### Existing condition

Existing lime-rendered wall before the Isolocork application.

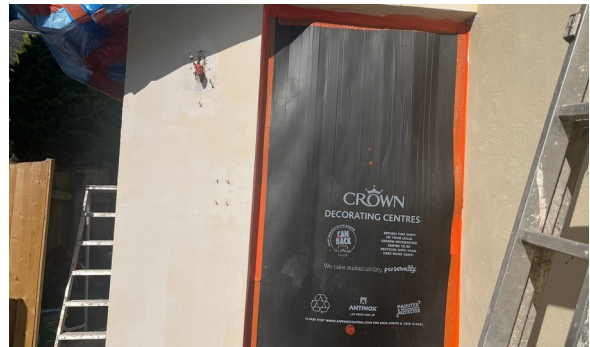
#### Substrate preparation

Existing lime-rendered surface prepared before coating, with openings and adjoining areas protected.

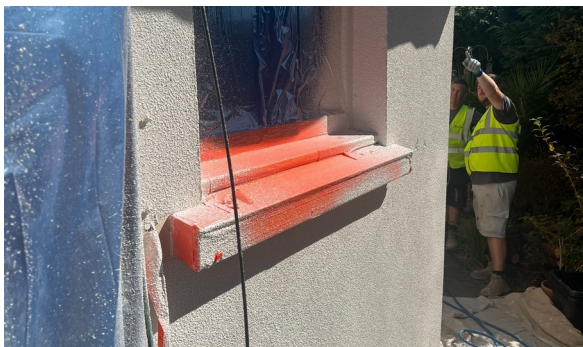
#### Application in progress

Openings, roof edges and adjoining surfaces masked and protected while the coating work progressed.

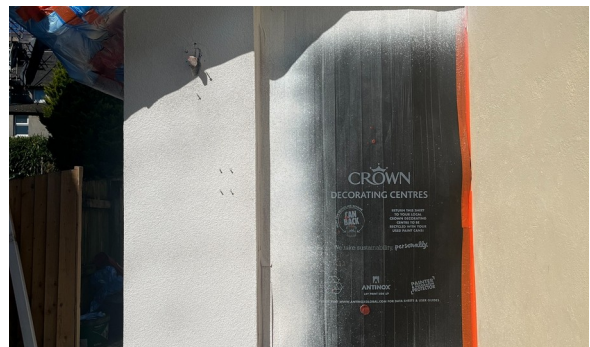
#### Coating application

Isolocork spray-applied across the prepared wall to form a continuous textured finish.

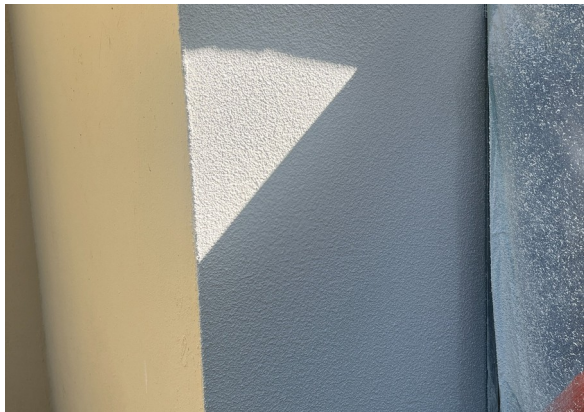
**Finished surface**

Close view of the completed Isolocork textured finish.

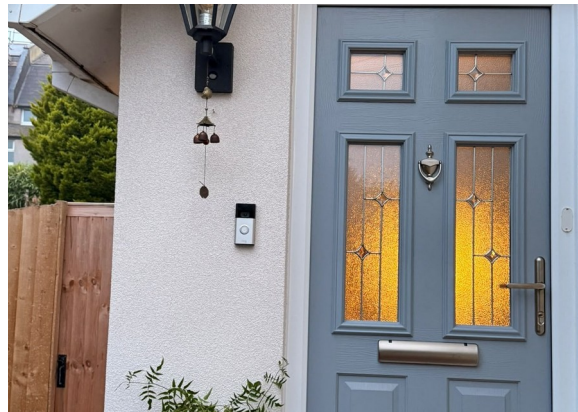
**Completed elevation**

Completed Ilfracombe elevation following the Isolocork application.
