# Woolacombe - Isolocork on SIP Extension

## Spray Cork Project Case Study

External finishing of a new SIP extension in Woolacombe. The wall build-up was prepared for the coating system before Isolocork spray cork was applied externally, creating a continuous textured cork-based finish across the extension.

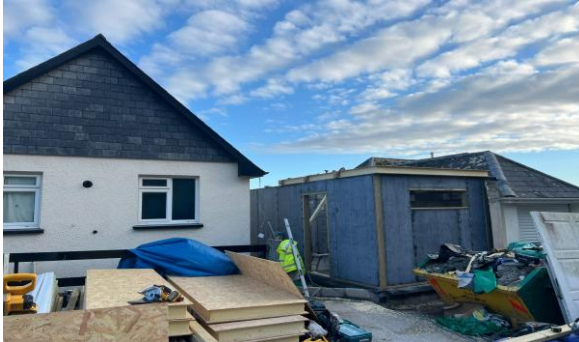
Construction stage

SIP extension during construction before the external wall finish was installed.

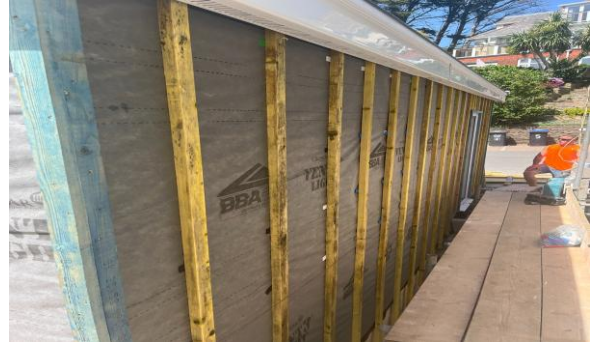
Wall build-up

External membrane and timber battens forming part of the wall build-up before boarding.

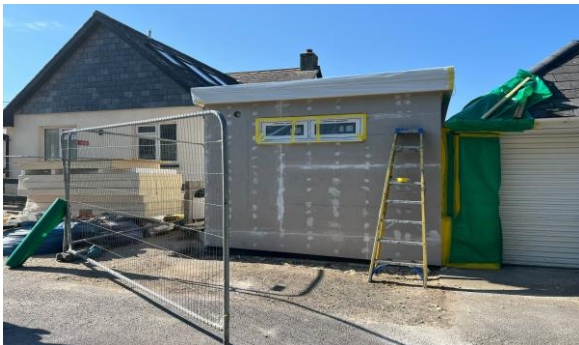
Board preparation

External boards fixed and joints and fixings prepared before the spray cork application.

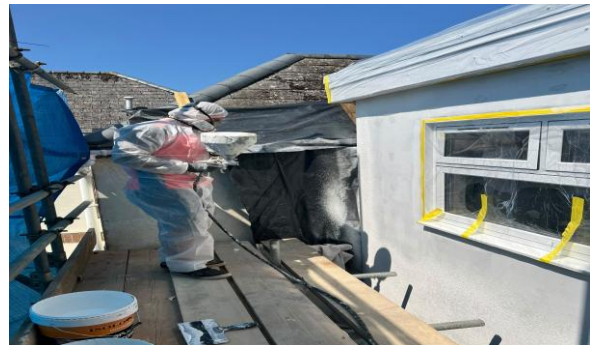
Isolocork application

Isolocork spray cork applied to the prepared external surface with openings protected.

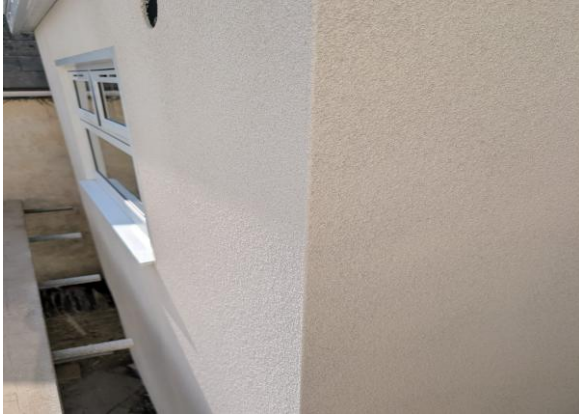
Finished surface  
Close view showing the continuous textured Isolocork finish.

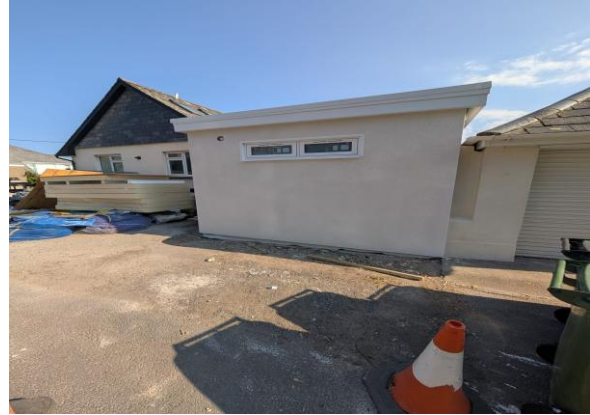
Completed extension  
Completed Woolacombe extension with the Isolocork external finish.
