Porto - Shipping Container Office  
Spray Cork Project Case Study

## Project overview

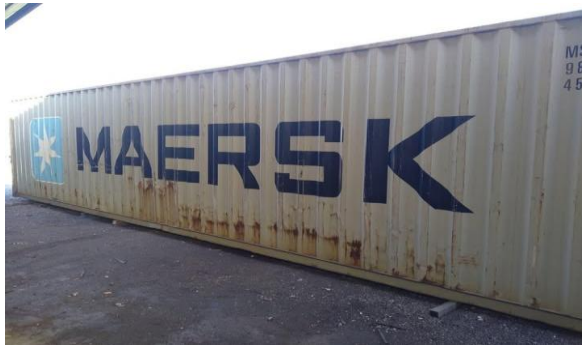
Original container

Steel shipping container before conversion and application of the external cork finish.

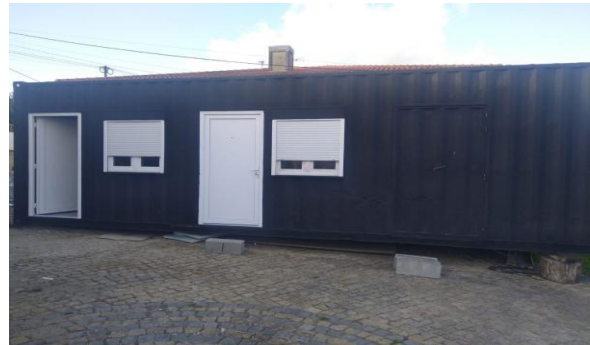
Converted container

Completed office conversion with black Isolocork applied across the corrugated steel exterior.

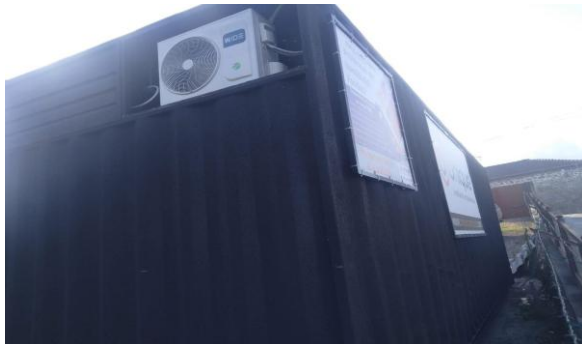
Continuous coating

Black Isolocork follows the original corrugated container profile across the external walls.

This project shows Isolocork used as the external finish on a converted shipping container. The black spray cork follows the corrugated steel profile and creates a continuous textured finish across the container. The completed coating was also demonstrated under a 130 bar pressure-wash test.

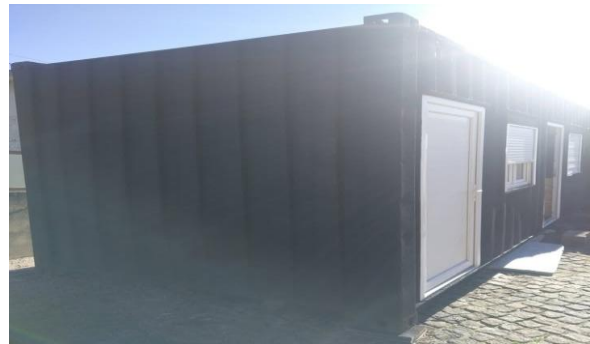
Finished exterior

Completed black textured finish around openings and external fittings.

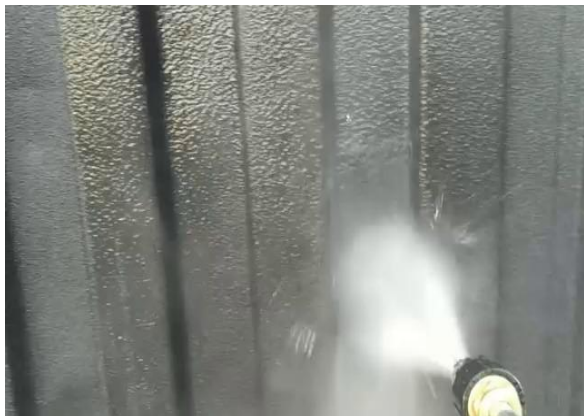
Pressure-wash test

Black Isolocork coating undergoing a 130 bar pressure-wash demonstration.

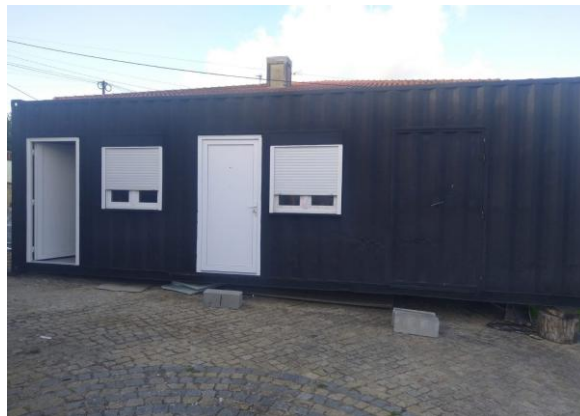
Completed finish

Overall view of the converted container with the continuous black Isolocork finish.
